Burning down the house: the burnt building V6 at Late Neolithic Tell Sabi Abyad, Syria

This article presents the remains of a T-shaped burnt building found in trench V6 in Operation II at Late Neolithic Tell Sabi Abyad, Syria. The burnt building closely resembles the so-called Burnt Village excavated earlier at Tell Sabi Abyad in Operation I, level 6, but is slightly older. Many objects were discovered in the ruins of the burnt building, but the most striking discovery was the burial of a young woman. In this paper we present the V6 burnt building and its remains. We argue that the building was purposely set ablaze as part of a ritual related to fire and death.

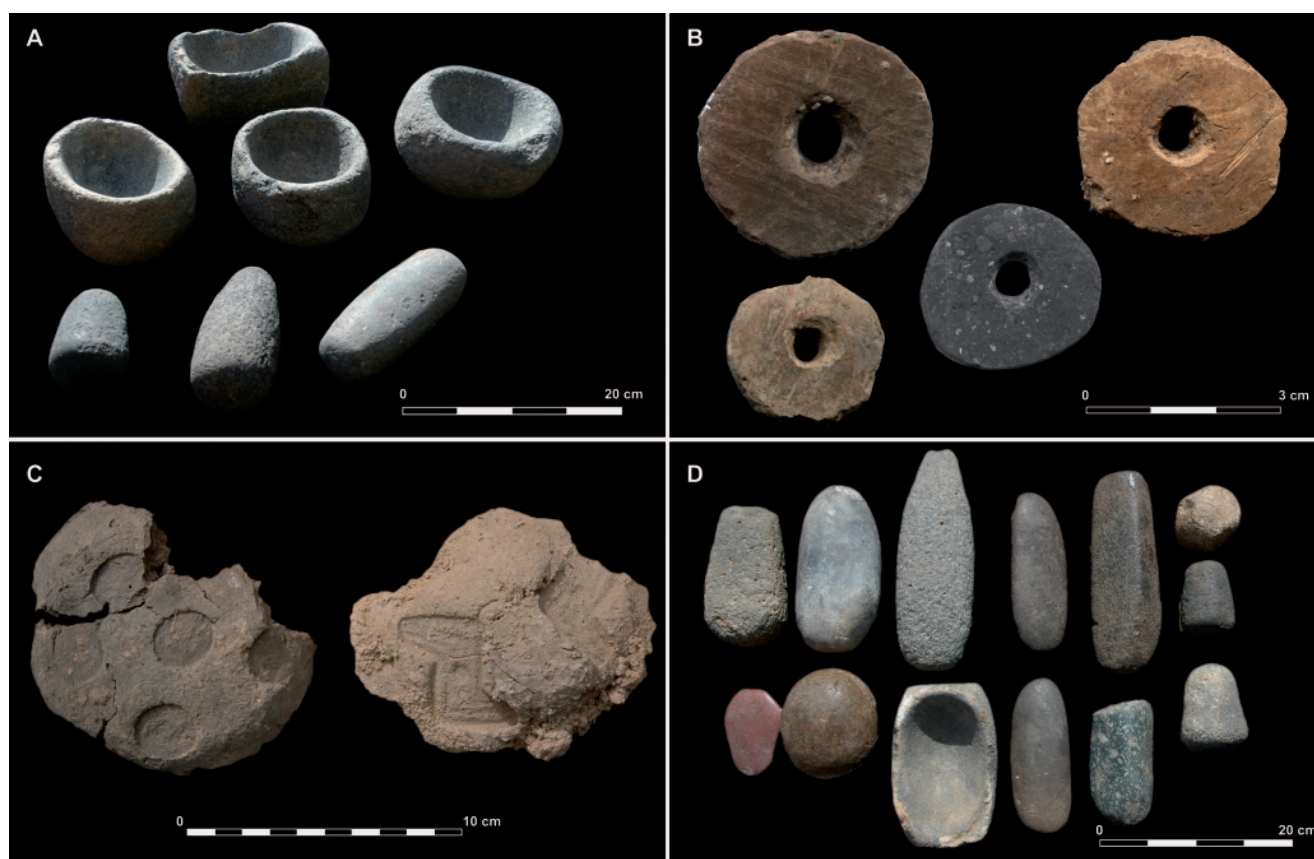
Figure 8 Tell Sabi Abyad. A selection of artefacts found in the burnt building V6. (A) Pestles and mortars. (B) Pierced discs. (C) Sealings. (D) Ground-stone tools.

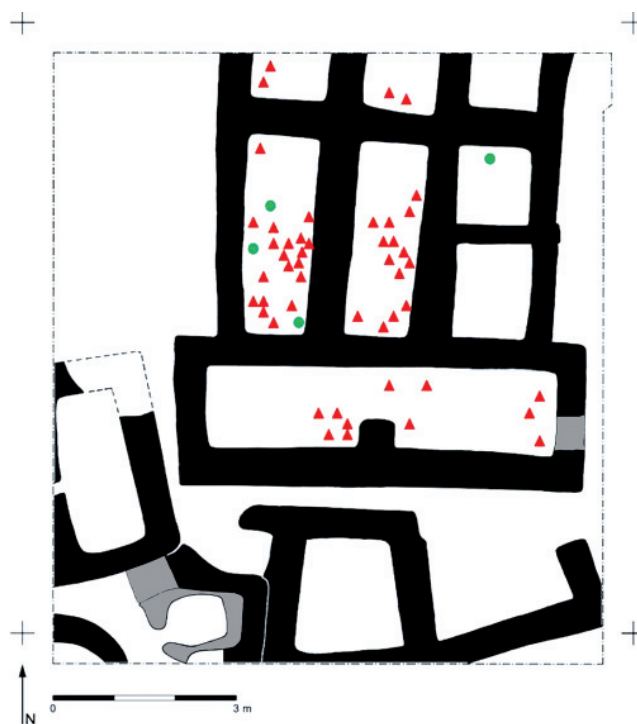
Figure 12 Tell Sabi Abyad. Distribution of roof material fragments in the burnt building V6. Clay roof fragments with reed imprints (red triangle), wood remains (green circle).

southwestern rooms 1 (n=19), 2 (n=14) and 5 (n=11), while only a few pieces were found in rooms 6 (n=2) and 7 (n=2) and none in the northeastern rooms 3, 4 and 8 (cf. fig. 12). They were widely distributed throughout the fill in these rooms, with some of them close to the floors (but never in the ashes immediately on the floors) and others higher up in

Significantly, the superstructure debris in rooms 1, 2 and 5 occurred in roughly two layers, with one layer of roof impressions at an elevation between about 80 to 120 cm above the floor and the other slightly lower at an elevation of 40–50 cm above the floor. While most imprints in room 1 were found in the upper layer, in the other rooms they were mainly in the lower layer. The occurrence of the impressions in layers suggests that the collapse of the roof in these rooms was not a single event but that it took place in a series of episodes. In the nearby room 6 the roof imprints were close to the floor, with wall debris on top of them. In the debris in the northwest corner of this room there was an ash midden; it is very likely that one part of the roof collapsed at a given moment, leaving the clay impressions, while another part kept burning, resulting in the midden. In all rooms the artefacts were found mainly in the fill below the roof imprints, while in the rooms with multiple levels of roofing material they were below and amidst both layers.
